Inspection and reliability assessment for Gandjelas concrete gravity dam

安哥拉 Gandjelas 混凝土重力坝安全检测与评价分析

Gandjelas dam is a gravity dam which is situated in Chibia province of Angola, with the reservoir capacity of $3.5 \times 10^6 \text{ m}^3$, maximum height of 30 m, downstream-face slope of 1 : 0.70. The dam was built in 1960s and 1980s by two different contractors. In 2005, rehabilitation of the dam was initiated by Sinohydro Corporation of China. Dam defaults such as horizontal construction joints, shrinkage cracks and visual defects are discovered. For safety, function and concrete durability of the dam, it is necessary to inspect the defects of dam concrete. The content of inspection and assessment is listed as follows:

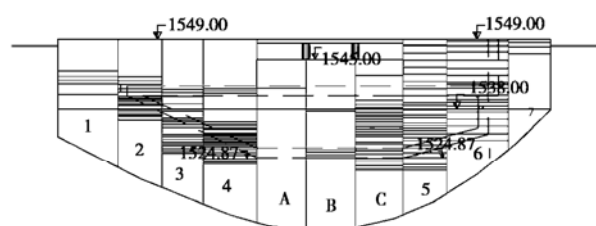
Fig. 1 Detectable construction joints and cracks of dam

According to inspection of drilled cores, the depth of construction joints are about 300~ 400 mm, and the width is just the same as that of surface, joints between two layers have bond characterization with yellow crystalline mass attached, although chisel-tooth had been done to construction layers, most surfaces of construction joints are smooth, and biting action of aggregate is small. In general, hairline of main construction joints and cracks disappeared in 600 mm, while that of minor construction joints and cracks is 200 mm.

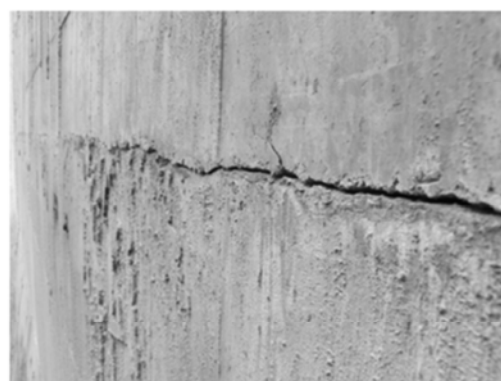
Fig. 2 Horizontal construction joints of upstream face

According to inspection, the depth of main upstream horizontal construction joints is 500 mm, while that of minor construction joints is 200 mm, so as on the wall of corridor. As a result, the integral stability is decreased and endangered dam safety according to DL5108-1999-Design Specification for Concrete Gravity Dams. Therefore, dangerous cracks are defined as viewed from dam safety.

For main construction joints and cracks, grouting permeability-reducing admixture (epoxy liquid) is used for the cracks and joints of the upstream surface, sealant material is used to seal the cracks on the surface, and impervious crystal cement material is coated on the upstream surface. Fig. 14 shows the repairing technique of construction joints and cracks. For minor construction joints and cracks, impervious crystal cement material is coated on the whole upstream surface.

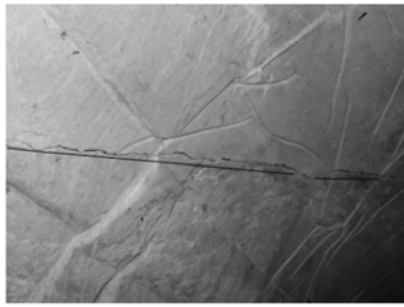
Fig. 3 Horizontal construction joints of corridor

Grouting permeability-reducing admixture is used

to repair the horizontal construction joints and cracks on the wall of corridor.

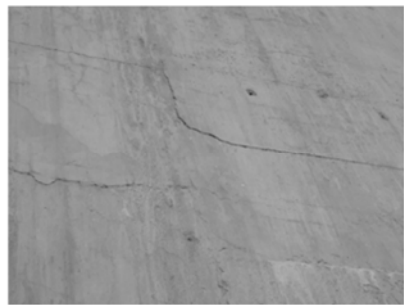
Fig. 4 Horizontal construction joints of upstream face

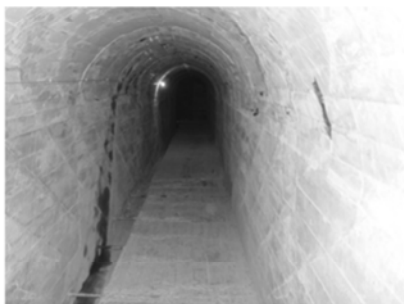
Fig.5 Circle cracks of top corridor

The cracks width of top corridor is 1~4 mm, the width of vertical cracks is less than 1 mm, relatively smaller than horizontal construction joints and cracks, and perpendicular to horizontal construction joints. The cracks in corridor and vertical cracks are caused by concrete shrinkage.

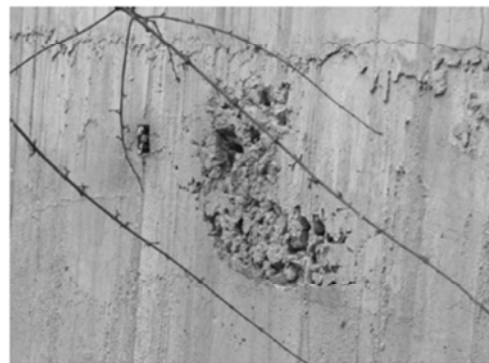
Although most of concrete face is smooth and integral, spongy is covered on concrete surface in some area (see Fig. 6). It is concluded that bad construction quality control during construction is the main reason. The spongy appears near the construction joints where aggregate is easy to be rolled and separated from concrete during pounding. As a consequence, spongy destroyed anti-permeation system.

Fig. 6 Concrete spongy in right side

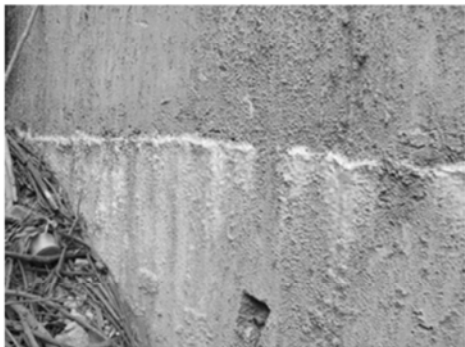
Separation CaCO_3 refers to decomposing of white crystal CaCO_3 on external surface from Ca(OH)_2 in concrete by means of small quantity of water (see Fig. 7). With development of water leakage, Ca(OH)_2 in concrete is decreased to its critic level. As a consequence, the hydration calcium silicate, hydration calcium aluminates, and hydration calcium ferrite are decomposed, when free Ca(OH)_2 in concrete is reduced down to 75%, concrete compressive strength is degraded to 50%, while Ca(OH)_2 reduced down to 67%, concrete compressive strength should be destroyed completely.

Fig. 7 Separation CaCO_3

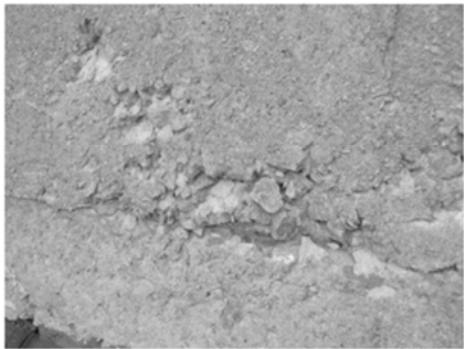
Concrete defects such as scaling, palling, efflorescence and popouts are presented in downstream face of spillway, see Fig. 8, so as the diversion holes, see Fig. 9.

Fig. 8 Defects in the spillway

Loosening, desquamation and abrasion are common defects to the concrete spillway. To deal with the illnesses, NBS mortar is suggested on the spillway repairing and maintenance, to prevent water from penetrating into corridor, the elastic sealing material is used to seal cracks on the spillway concrete.

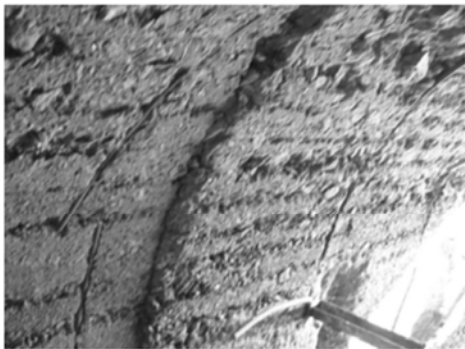
Fig. 9 Defects in the diversion hole

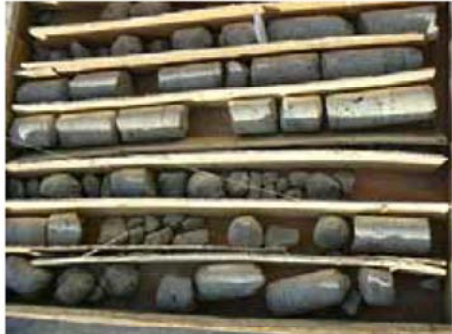
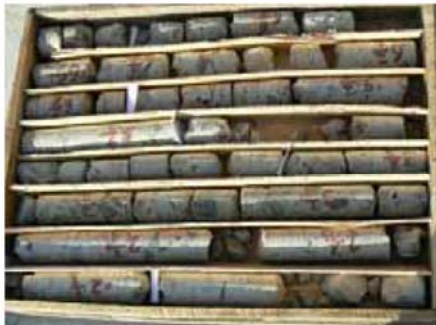
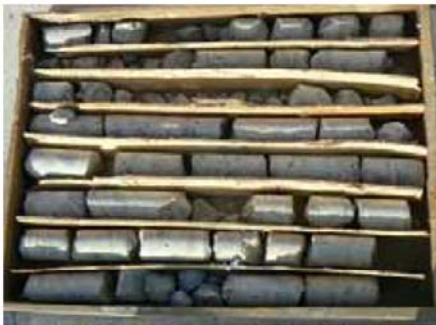
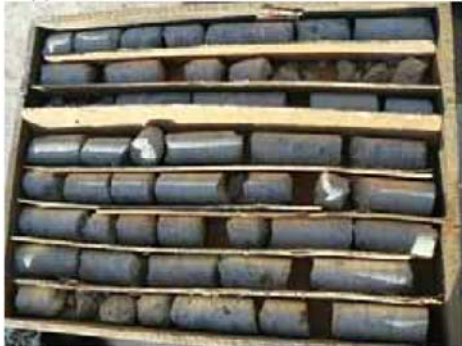
Fig. 10 Aspects of drill cores

Fig. 10 shows drilled cores, it is concluded that the cores are broken by concrete internal defects and construction joints, and the ratio of cores adopt is lower than normal level, the cores of foundation and dam turn into pieces.

(a) Cores of 1949.00~1942.00m of 1st hole

(b) Cores of 1942.00~1936.00m of 1st hole

(c) Cores of 1936.00~1930.00m of 1st hole

(d) Cores of 1930.00~1924.00m of 1st hole

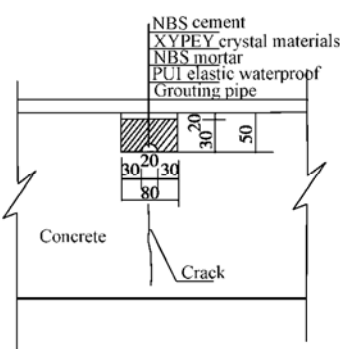
Fig. 14 Solving methods on level construction joint
