Inspection and reliability assessment for Gandjelas concrete gravity dam

安哥拉 Gandjelas 混凝土重力坝安全检测与评价分析

Gandjelas dam is a gravity dam which is situated in Chibia province of Angola, with the reservoir capacity of $3.5 \times 10^6 \text{ m}^3$, maximum height of 30 m, downstream-face slope of 1 : 0.70. The dam was built in 1960s and 1980s by two different contractors. In 2005, rehabilitation of the dam was initiated by Sinohydro Corporation of China. Dam defaults such as horizontal construction joints, shrinkage cracks and visual defects are discovered. For safety, function and concrete durability of the dam, it is necessary to inspect the defects of dam concrete. The content of inspection and assessment is listed as follows:

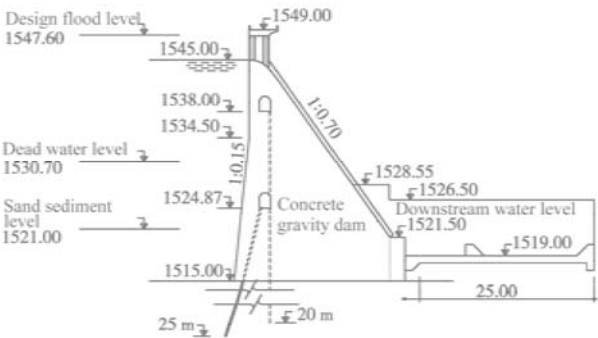
Fig. 11 Typical cross section

Fig. 11 shows typical cross-section, according to relative state, characterization water levels are: ① design water level: 1545.00 m; ② design flood water level: 1547.60 m; ③ dead water level: 1530.70 m; ④ sand sediment level: 1521.0 0m; ⑤ downstream water level: 1521.50 m.

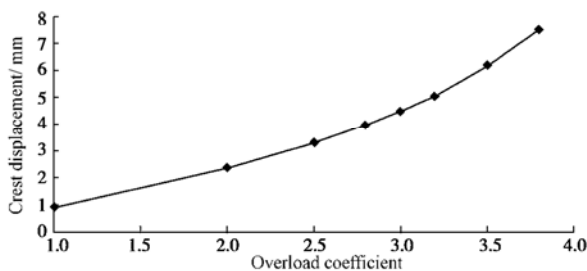
**Fig. 12 Variation of overload coefficient vs crest deformation**

Overload method is adapted to analyze the reliability of dam safety, the safety factor means the mutant-point of curve deformation (or its derivative)-overload coefficient. Table 13, Fig. 12 and Fig. 13 present the overload coefficient vs crest deformation and its derivative, and table 14 presents the safety factor k of stability required by SL253-2000 Design Specification for Spillway. It is indicated that the safety factor is 3.2, which satisfies 3.0 required in SL253-2000 Design Specification for Spillway.
